Date: 8 March 2018

PRE-2014 LH3600-5 YOKE SERVICE BULLETIN

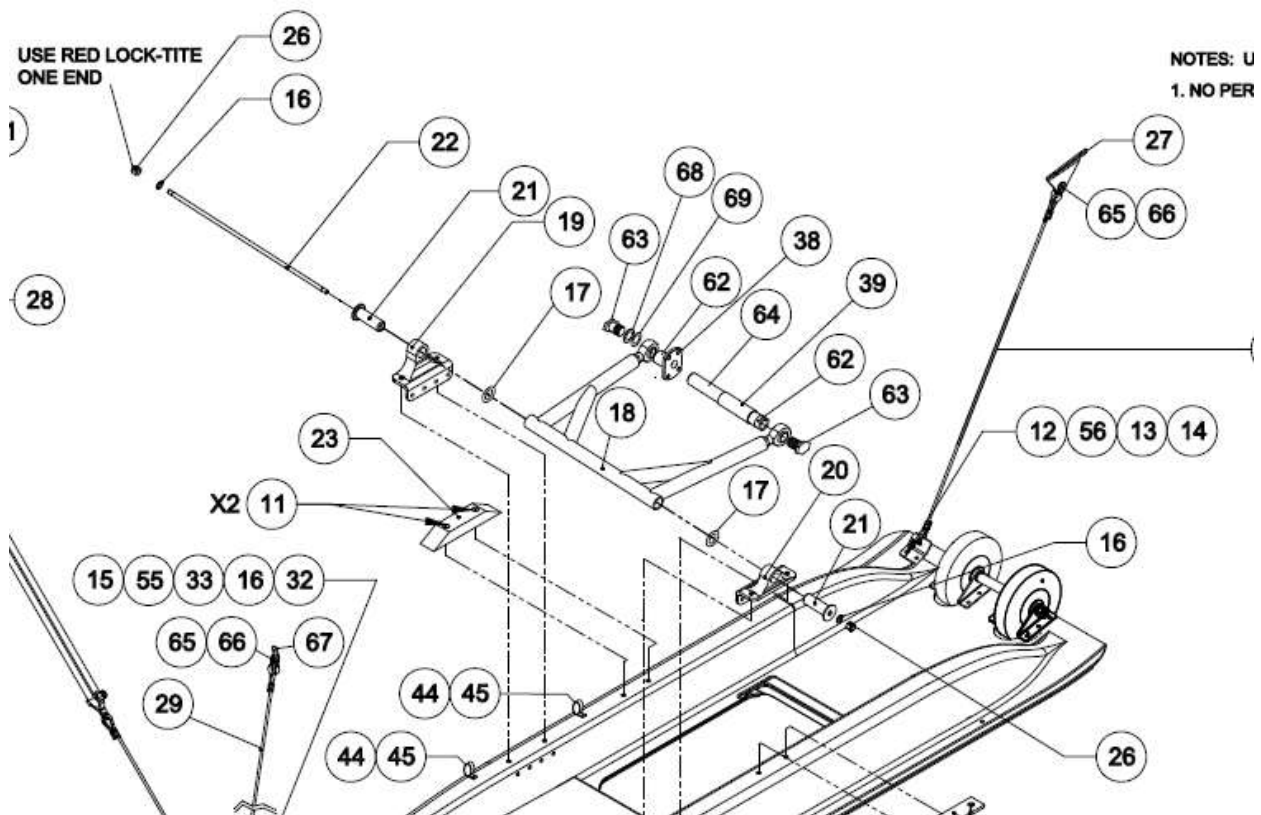
FIGURE 1

1. Prior to ski removal, disconnect all rigging, the aircraft can be hoisted or jacked to remove all rigging. We recommend removing rear check cable and forward safety cable first. Then aircraft can be hoisted or jacked to remove bungee cable. Rotating the ski down will relieve tension on the bungee for easier removal.
2. With ski supported, remove the two each NAS1312-15 bolts on each ski that go thru the CM-12 rod ends on yoke, see item 63 in figure 1.
3. Once rigging and NAS1312-15 bolts are removed, ski will be free of aircraft.
4. The next step is to remove the yokes from the skis. To do this (See Figure 1) remove axle rod nut (item 26). This will allow you to remove the axle rod (item 22), followed by the removal of the two buckets ((Item 21). The yoke will be free of the ski.
