MAINTENANCE AND INSPECTION CRITERIA

Section 7.0 MAINTENANCE AND GROUND HANDLING RESTRICTIONS

Section 10.0 MAINTENANCE TASKS

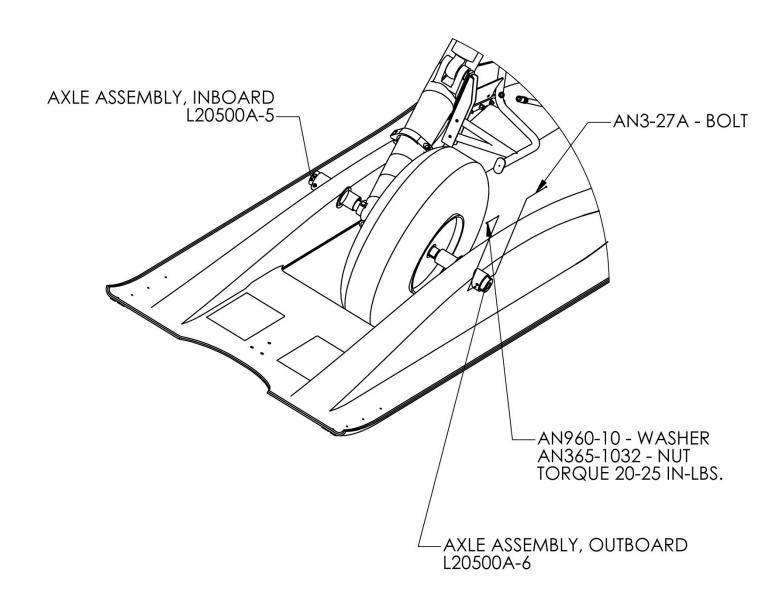
Figure 5.2

MAIN SKI – SPRING CYLINDER POSITIONING AND ASSEMBLY

- 12. Remove bolt(s) (AN3-27A) from Inboard and Outboard Axles and Ski Bushing. Retain Washer(s) (AN960-10) and Nut(s) (AN365-1032) onto bolt(s) *See Figure 5.2*.
