Date: 8 March 2018

PRE-2014 LH3600-5 YOKE SERVICE BULLETIN

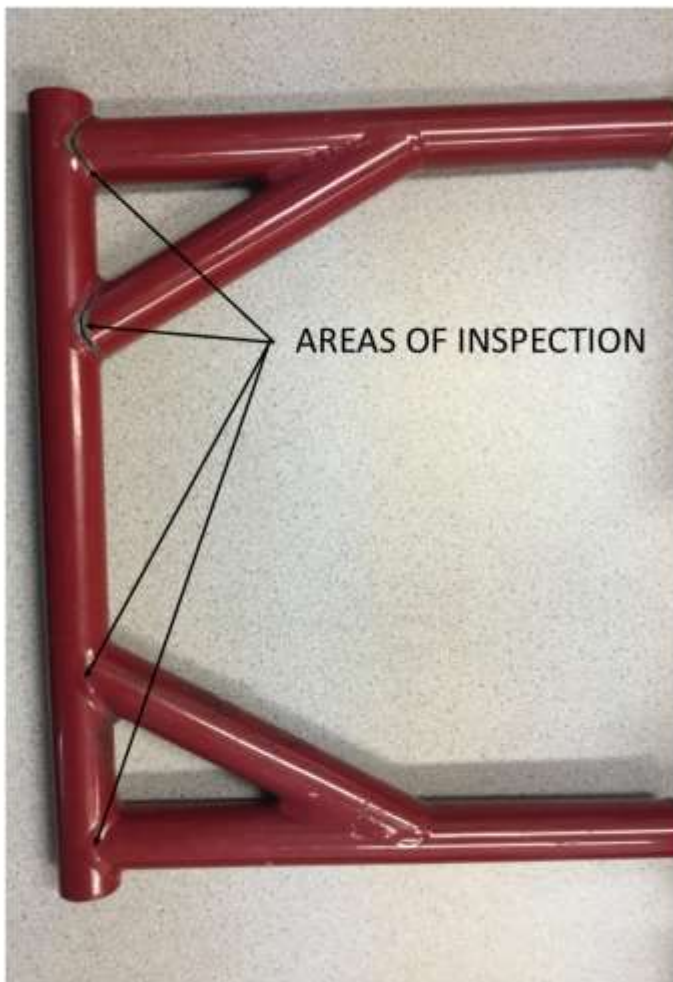
Airglas has received 4 reports of the LH4000 yoke (PN LH3600-5) of the welds shearing off the outboard arm of the yoke. The common thread between all occurrences is a heavy side load is applied to the skis. This sideways load appears to happen in a turn. In three cases, pilot reported to Airglas that they hit an obstruction in a turn.

The yokes Airglas manufactured up until 2014 were manufactured differently than current yoke. The older yokes were welded and then post heat-treated, followed by a mag-particle inspection. We have also seen some evidence that yokes may have been partially cracked, prior to final heavy side load occurrence. The yokes are powder coated, and this may be masking partial cracks.

7. If no cracks are found, we recommend a 1" wide .100 4130N finger strap be welded on the outboard yoke arms. This will be an intermediate fix for the yoke. Weld strap with the use of AC43-13-1B, Chapter 4. Length of finger should allow a minimum of 2" of weld on the outboard attachment arm on both sides. **Intermediate finger straps repairs will eliminate further inspection requirements.**

8. The **best option** is to replace yokes with current generation yokes. Current generation yokes are of much higher strength and very resistant to high sideward shock loads. These yokes are not heat-treated and have internal build-ups. The lack of heat treatment makes them more ductile. This is the best option to prevent future cracking problems. Airglas will offer yokes at a low cost for 24 months from the date of this Service Bulletin.
