20 AIRGLAS, INC ANCHORAGE, ALASKA 99507

#### MAINTENANCE AND INSPECTION CRITERIA

### REMOVAL OF SKISPROCEDURE

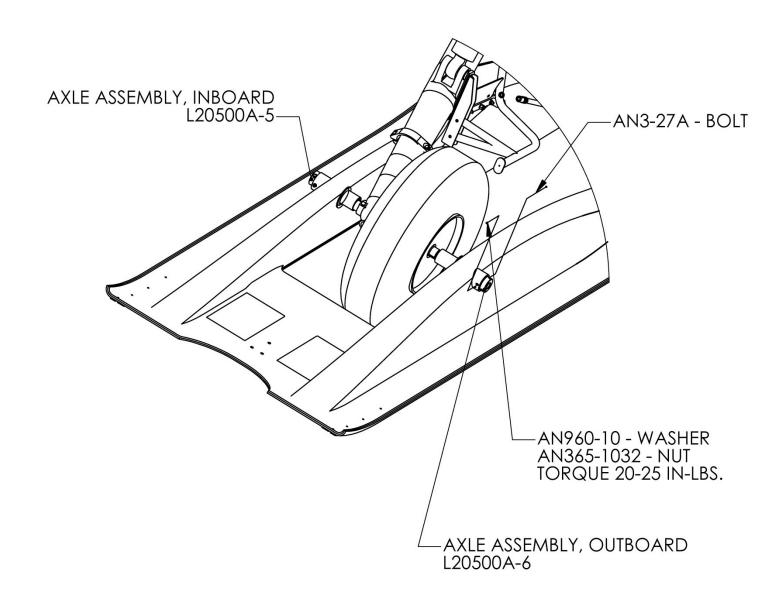
Figure 5.2

#### MAIN SKI – SPRING CYLINDER POSITIONING AND ASSEMBLY

- 12. Remove bolt(s) (AN3-27A) from Inboard and Outboard Axles and Ski Bushing. Retain Washer(s) (AN960-10) and Nut(s) (AN365-1032) onto bolt(s) *See Figure 5.2*.

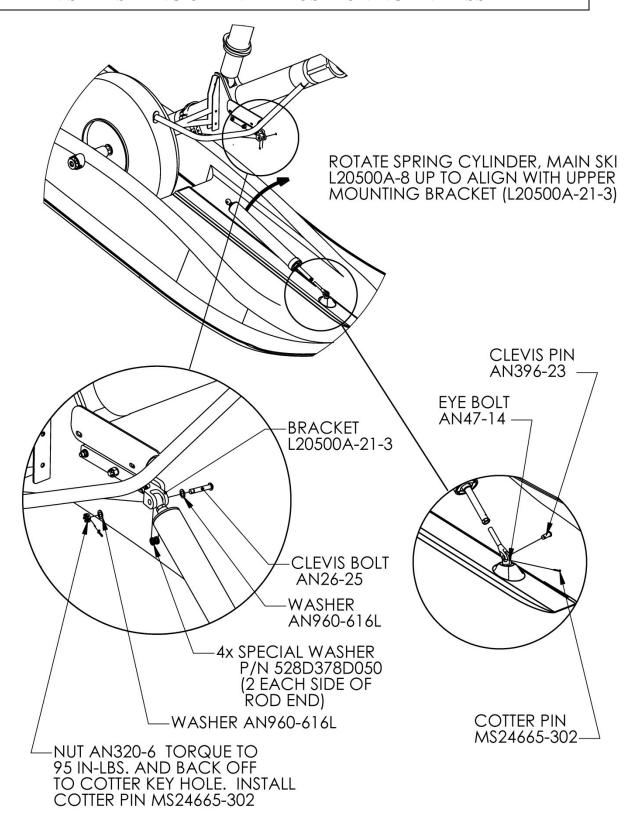
Figure 5.3

#### MAIN SKI – CHECK CABLE ASSEMBLY

- 13. Remove Spring Cylinder, Main Ski (L20500A-8) from Upper Mounting Bracket (L20500A-21-3), retain Clevis Bolt (AN26-25), (2) Washers (AN960-616L) and Nut (AN320-6), (4) Special Washers (P/N 528D378D050 (2 each side of rod end). *See Figure 5.3*

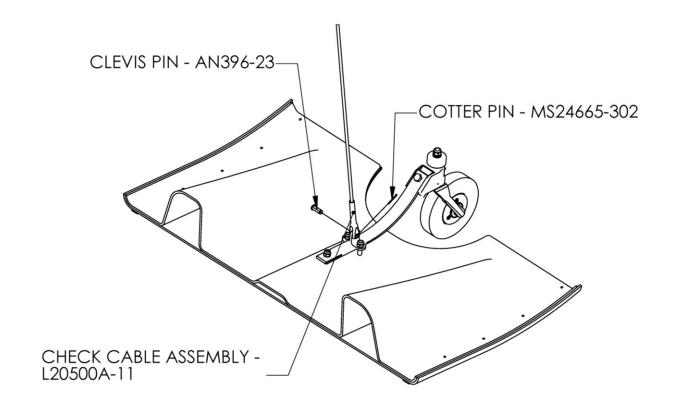
Figure 5.4

#### MAIN SKI – SAFETY CABLE ASSEMBLY

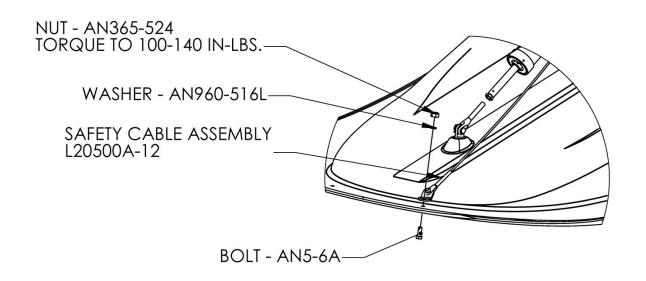
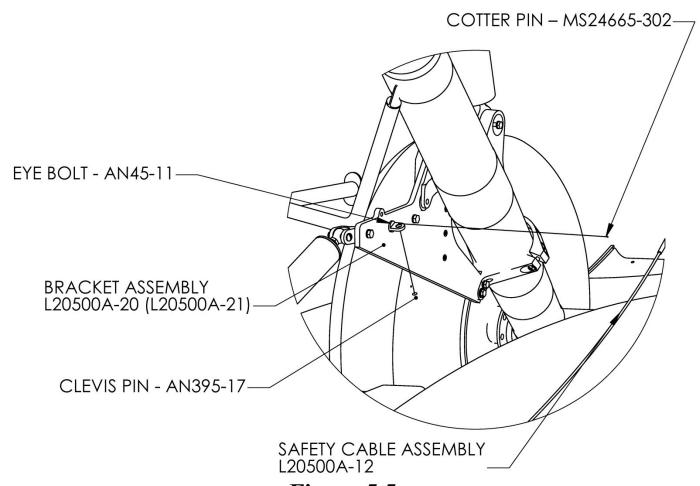
Figure 5.5

# PYLON CHECK CABLE BRACKET INSTALL

- 14. Remove upper end of Safety Cable Assy. (L20500A-12) from to Eye Bolt (AN45-11) at 2<sup>nd</sup> hole back on Bracket Assy. (P/N L20500A-20, L20500A-21) Retain clevis pin (AN395-17) and cotter pin MS249665-302. *See Figure 5.5*

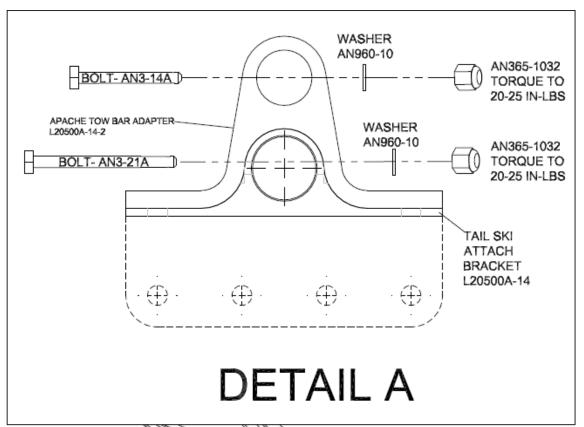
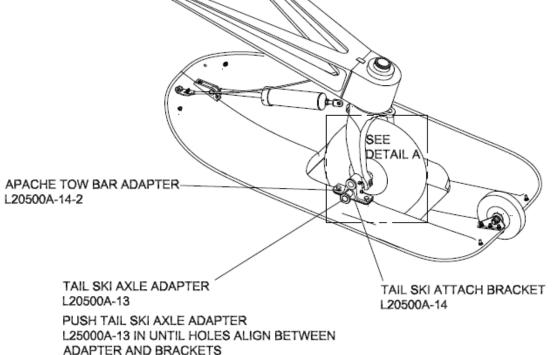
# FIGURE 6.1

#### TAIL SKI – SPRING CYLINDER POSITIONING AND ASSEMBLY

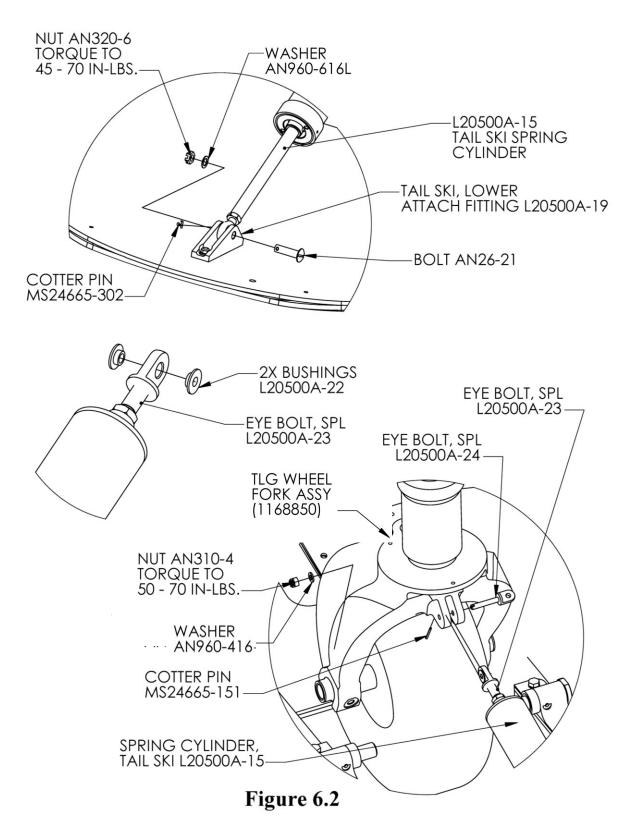
#### TAIL SKI – SAFETY CABLE ASSEMBLY

- 3. Hold the Spring Cylinder in one hand, lift the front of the ski, and remove the L20500A-24 from TLG lug. Retain the upper Spring Cylinder Eye Bolt (L20500A-23) and Bushings. After removal from the TLG lug, loosely reinstall the L20500A-24 back into the L20500A-23 Eyebolt, using the Washer (AN960-416) and Nut (AN310-4). Note: The Safety cable (L20500A-17) can remain attached to eyebolt (L20500A-24) for storage. *See Figure 6.2*
